Project Name: Gold King Mine	Site Location: Silverton, San Juan County, Colorado	Project No. 0001/1408-01
--	---	------------------------------------

PHOTOGRAPH LOG

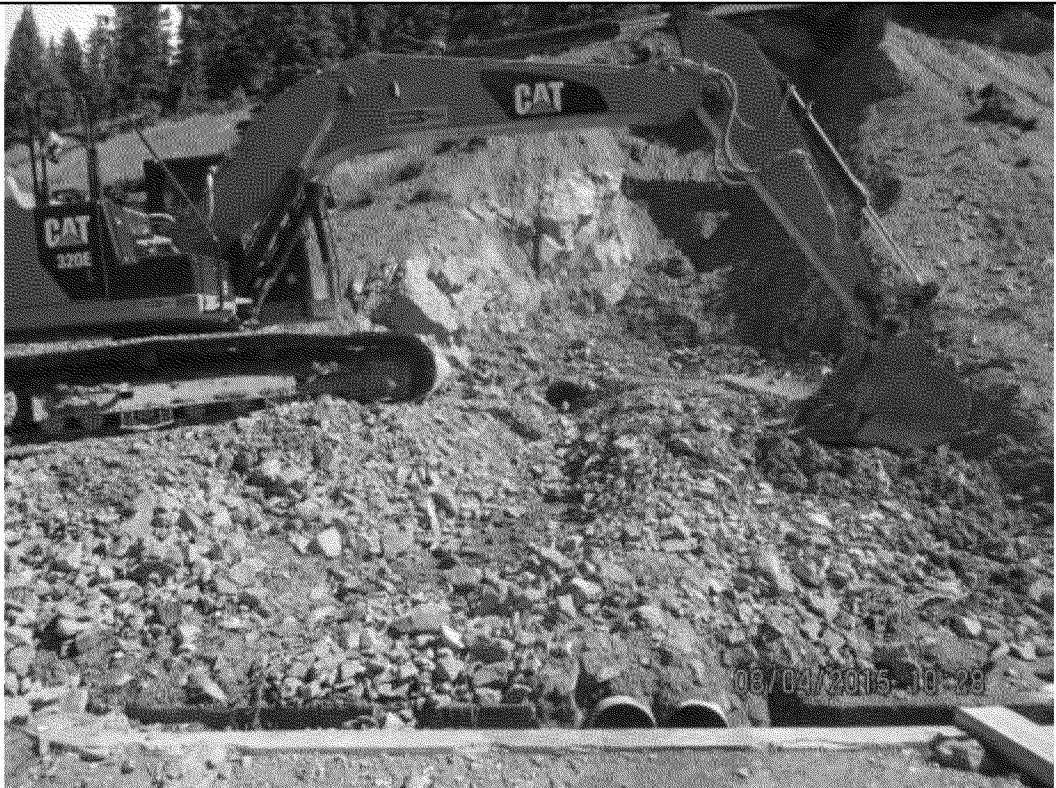
Photo No. 1	Date: 08/04/2015

Direction Photo Taken: North		
Description: Beginning investigation into collapsed adit.

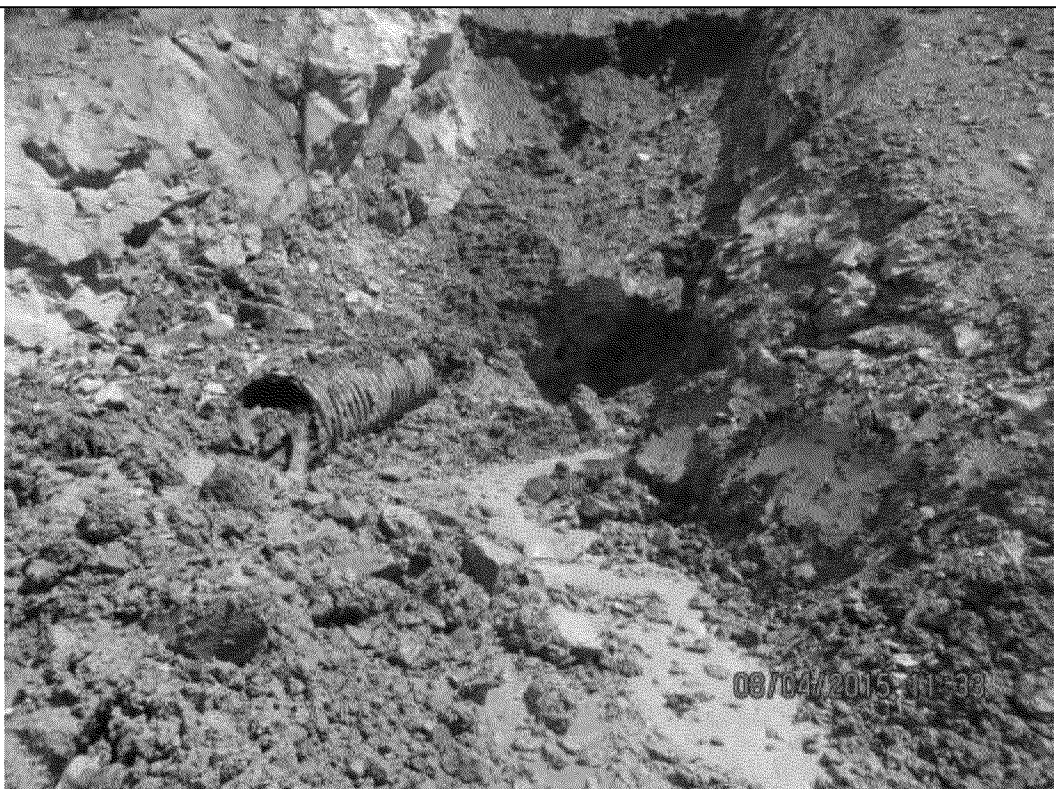
Photo No. 2	Date: 08/04/2015

Direction Photo Taken: North		
Description: Excavated next to DRMS-installed culvert, water muddy from soil disturbance.

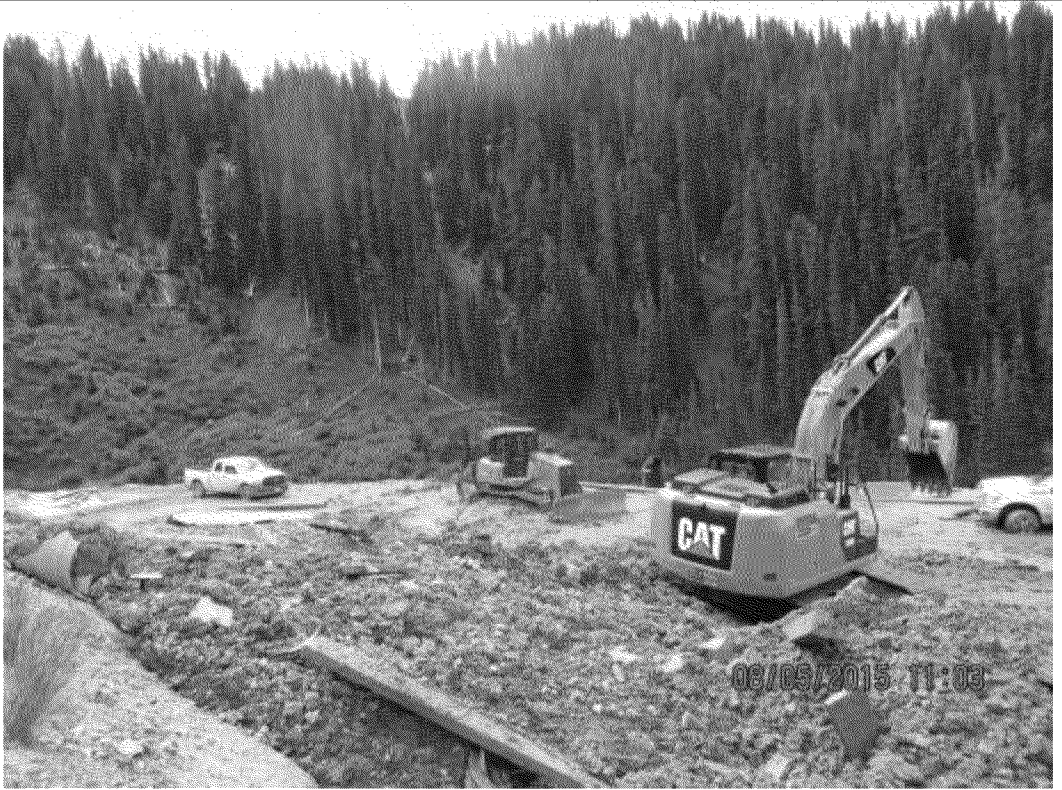
Direction Photo Taken: Southeast		
Description: Water flowing over the edge of the waste dump and collapsing the edge.

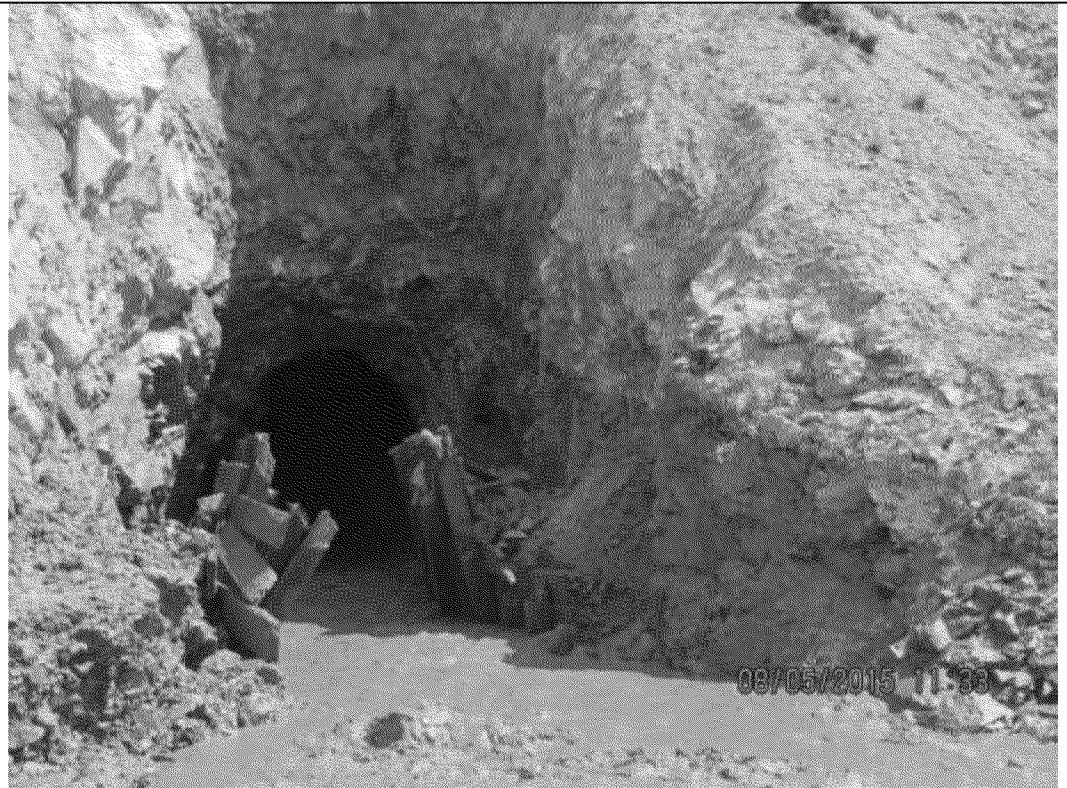
Photo No.
27

Exposed adit, roughly 10 feet wide by 15 feet high.

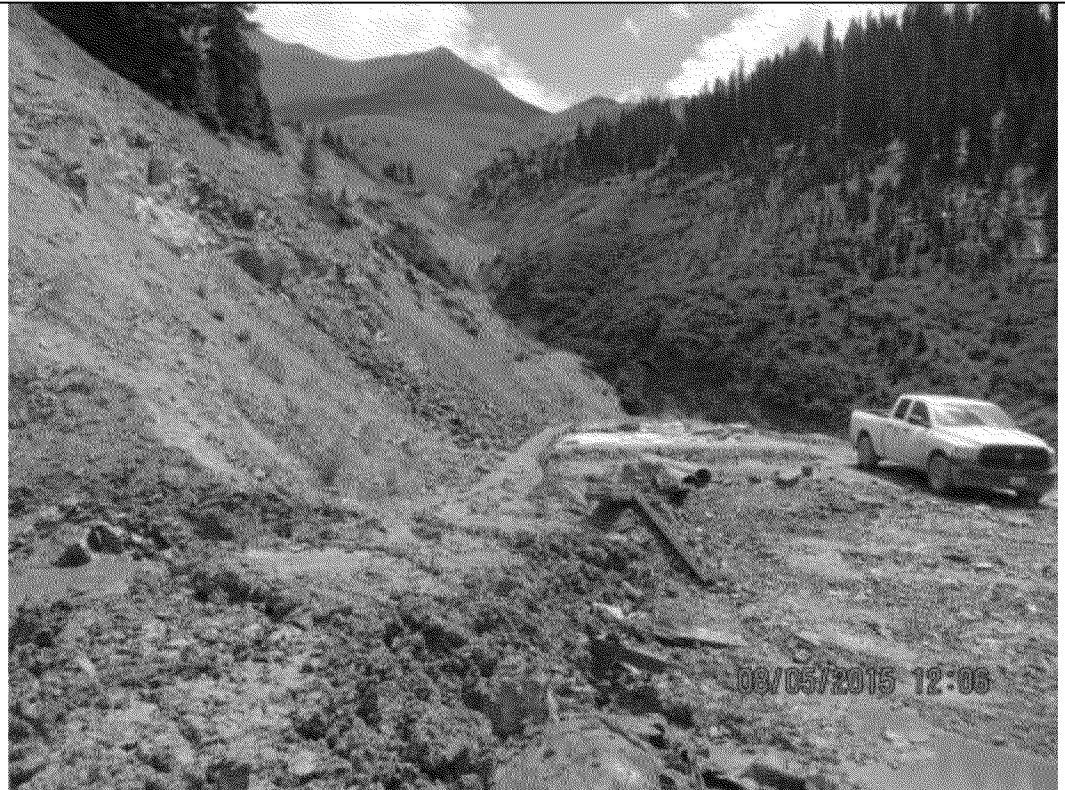
Photo No.
33

Redirected flow into existing half culvert channel.
